Technical article, published in: konstruktionspraxis (3/2020)

Extreme tests in real-life conditions

Various steute switchgear series are currently being tested in real-life conditions on the island of Helgoland. The results are used to improve the development of new product series.

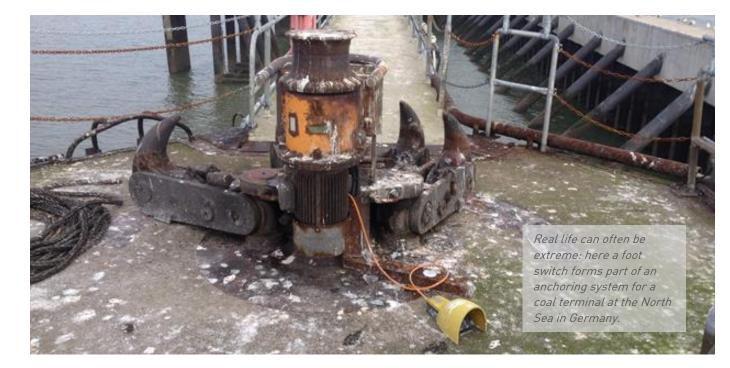
After one year in tidal water or splash water, the various devices are all still functioning. Even labels and laser inscriptions are still attached and legible.

been running since September 2017 is providing comprehensive answers to this question. On the island of Helgoland in the North Sea, the Fraunhofer IFAM institute has a remote test facility. Here, components are fixed to a test rack and then lowered into the sea – directly on the quay and thus in real-life conditions, either in splash water or tidal water. In addition to the salt water and the weather, other reallife factors such as fouling (algae growth) also impact the test specimens, which are then examined on land after a fixed period

The test results are positive, both optically and functionally: even after a year in tidal water or exposed to the impact of splash water, the devices from the various series all still work without any problems. Even the labels and laser inscriptions are still attached and legible. The pre-treated and powder-coated housings of, for example, the foot switches present in a very good condition, while the internal switching inserts, plungers or pedal pivot shafts are free of corrosion.
